FEDERAL BUILDING (NM0024ZZ) 517 GOLD AVENUE, SOUTHWEST ALBUQUERQUE, NEW MEXICO

ASBESTOS BUILDING AUDIT SURVEY CC: TPMF - AQ

SEPTEMBER 5 - 15, 1995

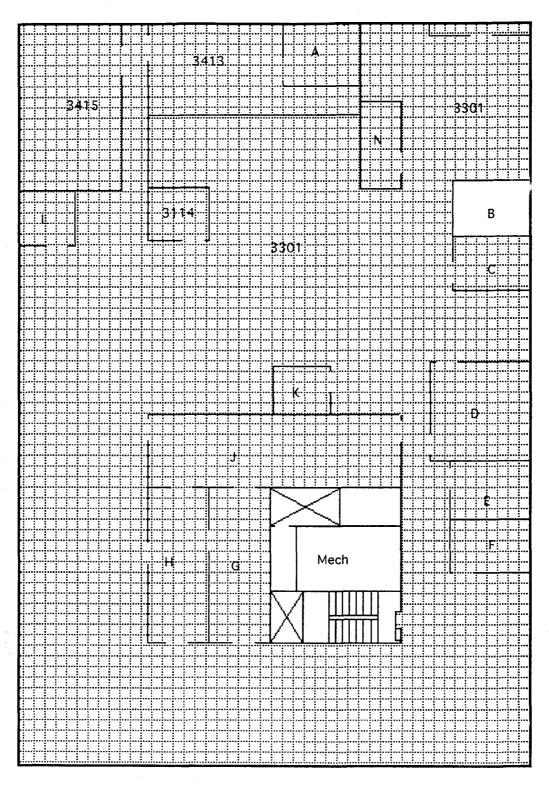
FLOORTILE	Second Floor - East	
	Miscellaneous Other Material	is
U. S. Federal Building - (NN	M002477)	Albuquerque, NM

9" x 9" floor tile was found throughout the building, often under carpet. Several samples of these tiles, which exist in a variety of colors, were found to contain asbestos. As a result, all occurrences of 9" x 9" floor tile, including any which may not be specified in this report, should be considered to contain asbestos.

Samples of black floor tile mastic collected from various locations in the building were found to countian asbestos. It is possible that not every occurrence of this material has been identified. As a result, all occurrences of black floor tile mastic, including any which may not be specified in this report, should be considered to contain asbestos.
